Contract #: 04-0120F4Cty: SF/ALA Rte: 80 PM: 13.2/13.9File #: 69.28**WELDING INSPECTION REPORT****Resident Engineer:** Pursell, Gary**Address:** 333 Burma Road**City:** Oakland, CA 94607**Report No:** WIR-000415**Date Inspected:** 03-Sep-2007**Project Name:** SAS Superstructure**OSM Arrival Time:** 630**Prime Contractor:** American Bridge/Fluor Enterprises, a JV**OSM Departure Time:** 1530**Contractor:** Zhenhua Port Machinery Company, Ltd (ZPMC), Changxing Island **Location:** Shanghai, China**CWI Name:** Xiu Zhai Gu**CWI Present:** Yes No**Inspected CWI report:** Yes No N/A**Rod Oven in Use:** Yes No N/A**Electrode to specification:** Yes No N/A**Weld Procedures Followed:** Yes No N/A**Qualified Welders:** Yes No N/A**Verified Joint Fit-up:** Yes No N/A**Approved Drawings:** Yes No N/A**Approved WPS:** Yes No N/A**Delayed / Cancelled:** Yes No N/A**Bridge No:** 34-0006**Component:** N/A**Summary of Items Observed:**

**Mock-up 114**

### Mock-up 77

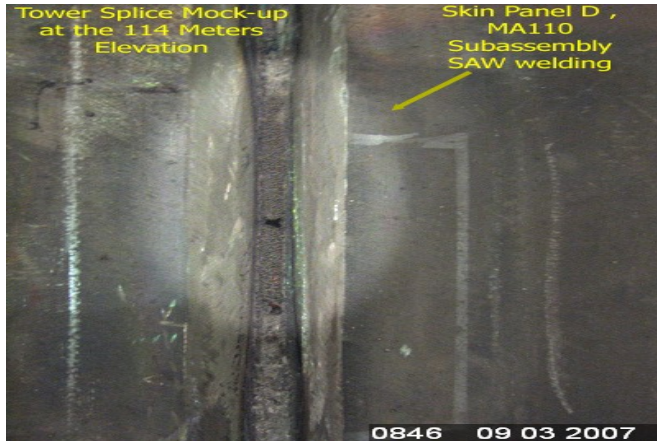
However, after completing the root pass ZPMC/ ABF and Caltrans observed a melt-thru on the root approximately located at 800 mm from the edge of the plate see photo below.

ZPMC removed by grinding the melt-thru area at the root area (approximately 150 mm of weld metal and the face of the root). The QA inspector performed dimensional inspection to the root gap. The QA inspector found a root gap between 6 to 7 mm. See digital photograph attached. The QA inspector had a conversation with ABF

representatives Kevin Dye and Kevin Carpenter. The QA inspector asked to ABF representatives on how ZPMC was going to proceed since the root gap was not per WPS or AWS D1.5 2002 tables 2.4 and 2.5. Mr. Carpenter and Mr. Dye relayed to the QA inspector that ZPMC planned to weld the root by welding. ZPMC welded the 7 mm root gap bridging both side of the joint with the SMAW process. The QA inspector observed Mr. Guo performing welding operations following the parameters listed by the WPS-345-SMAW-1G (1F) Repair. ZPMC was using the Shielded Metal arc welding (SMAW) process in the flat (1G) position with the 4.0 mm diameter electrodes designated as E7018/AWS A5.1, brand name TL-508. The QA Inspector verified amperages, preheat and heat interpass temperatures. The QA inspector observed approved ZPMC Certified Welder Inspector Cui Yi Rui verifying welding parameters. Later on the shift before ZPMC performed magnetic particle testing (MT), the QA inspector observed a linear indication on the entire length of the repair area. The QA inspector brought to the attention of Mr. Dye, Mr. Brundardt and Mr. Song that the repair area was cracked. The photo below shows the repair area before and after the weld cracked. ABF requested ZPMC to submit for approval the repair at the skin panel D, repair located at the junction of plate MA110 and plate mp1016.
